USACE Technical Assistance to Santa Barbara County Regarding Flood Control Operations on the Santa Maria River

Introduction

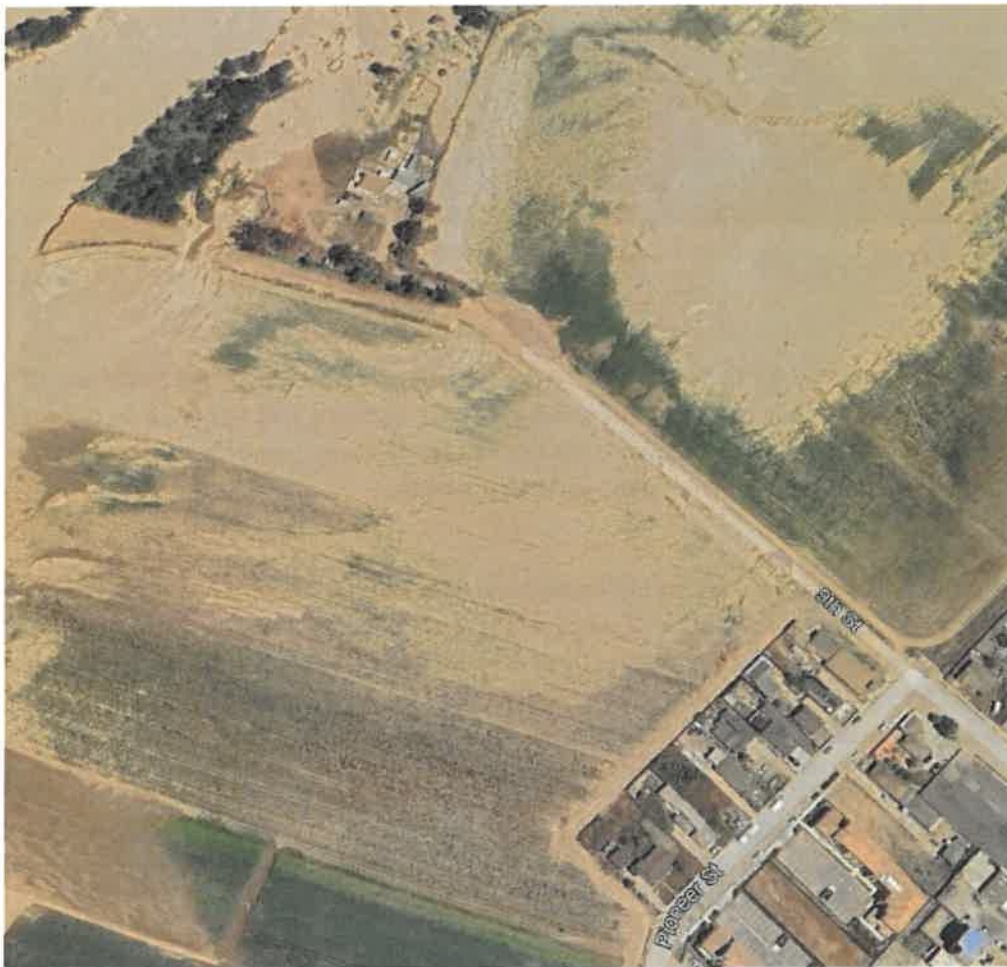
As shown in Figure 5, a residence exists to the west of Pioneer Street at the western end of 9th Street. It lies quite close to the river, and Guadalupe's Fire Captain stated that water was approximately 6 feet deep here during the January storm.

Figure 5. 9th Street House (seen in upper mid-left of picture)

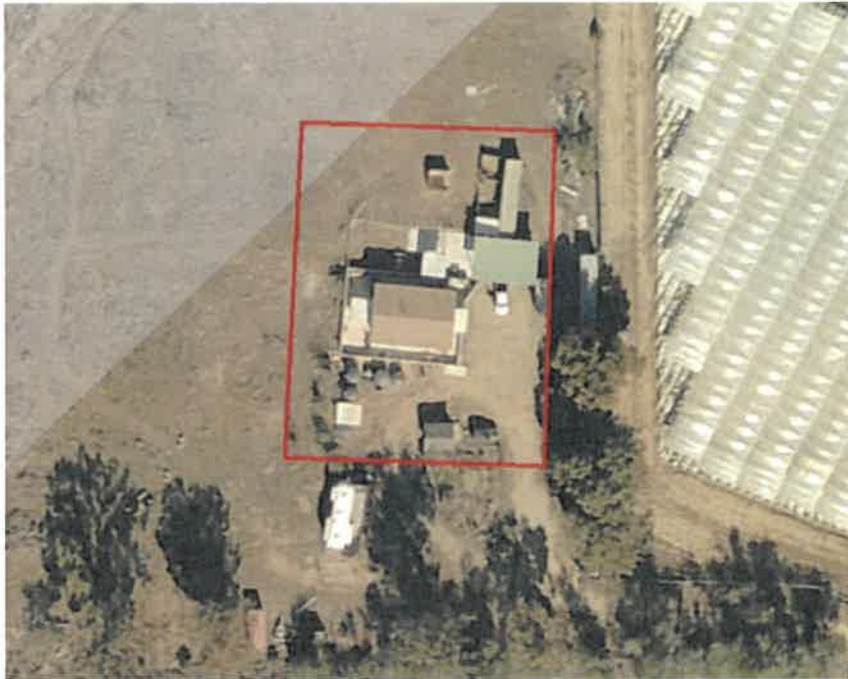
Figure 6. HESCO Alignment for 9th Street House

USACE suggests that a ring of HESCO baskets could be applied here and one possible alignment is shown in Figure 6. It is possible fill these baskets in advance, but leave an opening in the barrier until the storm is approaching and then fill and close the ring. A suggestion has been made by the County of Santa Barbara that a passage through the barrier be left, but this passage built up as a permanent exit and entry point roughly equal in elevation to the intended top of barrier. This could be an effective way to allow egress, as long as the slopes are implemented somewhat gradually, since the HESCO baskets have limited flexibility to adjust quickly changing ground slopes.

Cost estimates have been provided for this option and are attached, with one including a single row of baskets and one including a stack two rows high. Detailed hydraulic modeling was not done on this area, because accurate topo data was not available at the time. Both cost estimates are provided to allow Santa Barbara County to decide which height of barrier to implement.

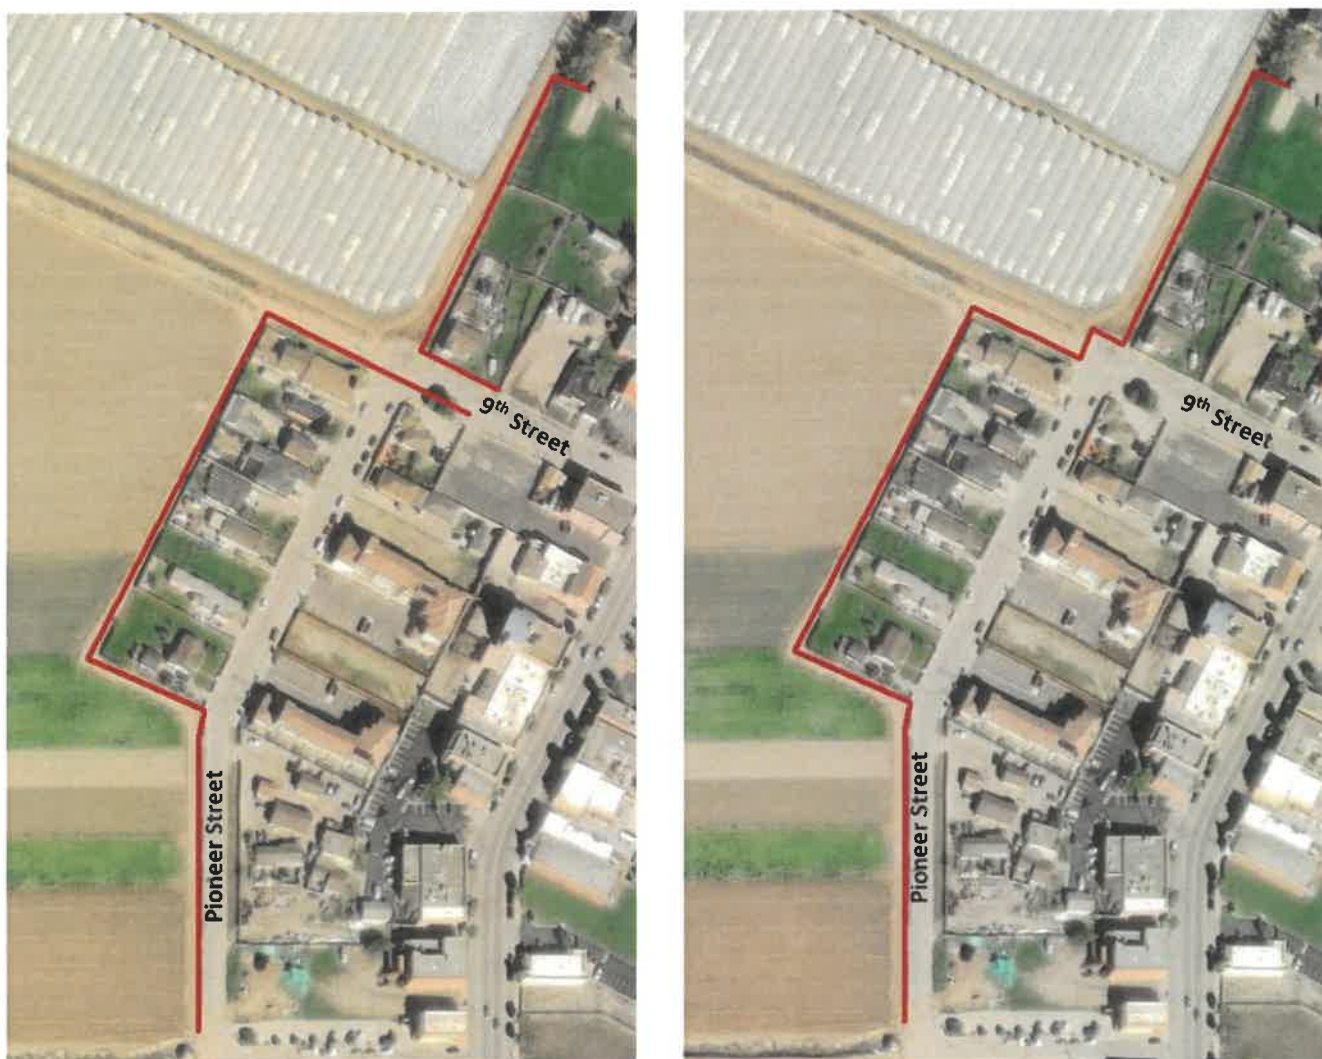
Anecdotal evidence (from Guadalupe's Police Chief) places the high-water mark of the January storm at about 3 feet high for buildings on the west side of Pioneer Street in Guadalupe. Water was only about 1-2 feet high for buildings on the east side of Pioneer Street. No flooding occurred in this location during the March storm and the most recent flooding known prior to the January 2023 events was in December 2010, which was nearly identical in magnitude to the January 2023 storm in flow rate.

A breakout point on the left bank of the Santa Maria River, looking downstream, a few hundred feet downstream of the Hwy 1 bridge (shown in Attachment 1) is believed to have contributed to this flooding. The cross section of the channel is relatively small and other flow paths may have also contributed to the flooding at Pioneer Street.

Figure 7. Pioneer Street HESCO Alignment Options A (left) and B (right)

HESCO baskets are recommended as the best solution for Pioneer Street and two possible alignments are presented for consideration in Figure 7. Alignment A allows for passage on 9th Street to the house referred to the section above, but may create access issues for the house on the NE corner of Pioneer and 9th Streets, while Alignment B allows two exits from Pioneer Street and will not create access issues for the house on the NE corner of Pioneer and 9th Streets. On the other hand, it would cut off access for the house at the end of 9th Street unless a ramp or other method of passing was established. Since 9th

Street rises noticeably going eastward from Pioneer Street, the distance these baskets rise along 9th Street will determine their effectiveness.

A cost estimate for the Pioneer Street HESCO baskets is being provided in .xlsx format with this report and applies to either alignment, as both require a very similar total number of baskets. A four foot high barrier is recommended solely based on the estimated height of water from Guadalupe’s Police Chief.
