# CITY OF GUADALUPE

PROJECT: City Hall Repair Project Design Services

**ADDENDUM NO.: 4**

EVALUATION REPORT

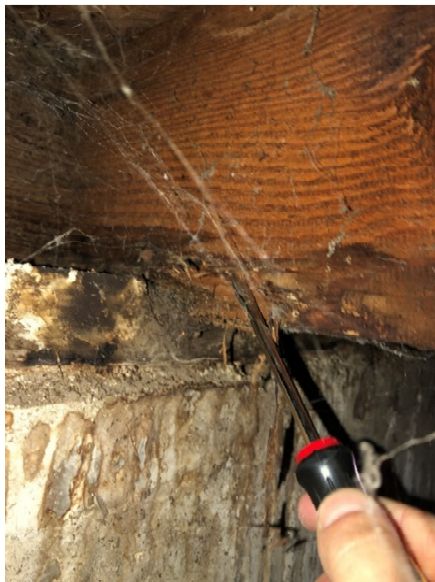
Figure 2: Observed damage to joist and sill plate

The wood floor framing has several deficiencies, primarily due to age and lack of moisture barrier and delayed maintenance of the building's exterior envelope. The majority of joists are "soft" within 6-inches to 12-inches of the joist ends along with signs of fungus and decay. Along with water damage, it was observed that Joist J10 (location as noted on the provided conceptual plan on Appendix B) is splitting along the bottom of the joist. It is assumed that other joists within the vicinity not specifically observable may be in a similar condition.

The sill plates supporting the joists are very "soft" and is easily penetrated with minimal amount of applied pressure to the wood. The sill plates are also beginning to show signs of crushing failure within the first 10 joists (Joists J1 to J10 on the provided conceptual plan on Appendix B). Beyond Joist J10, the sill plates have failed due to crushing and joists are bearing on the top of concrete wall.

It is recommended that the joists be immediately shored to provide a sufficient bearing surface for the floor joists and prevent further damage to the structure. Appendix B includes a detail of the temporary repair until a retrofit solution can be implemented. A repair plan should be developed that incorporates structural retrofit plans and details as well as other reports and documentation required by the California Building Code. In addition to replacing the deteriorated structural components of the structure, it is imperative that the exterior of the building is has an appropriate moisture barrier installed to prevent damage to the structural repairs.

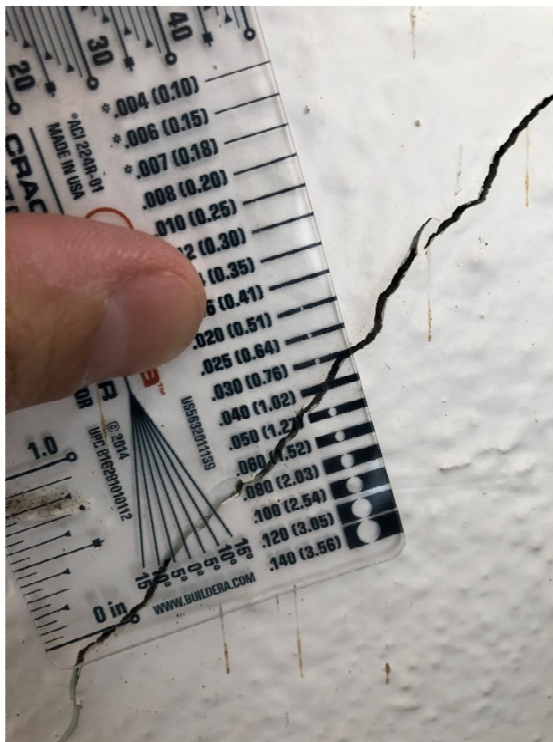
Figure 4: Observed cracking of interior finishes

There are noticeable cracks in the exterior and interior finishes due to structural distress. Cracks in the interior finishes ranged from 0.016" to 0.04". While on site, it was mentioned by a representative of the building site that cracks had noticeably propagated further up the wall over the span of a week's time. Cracks will continue to propagate and increase in size as sill plates continue to experience crushing failure.

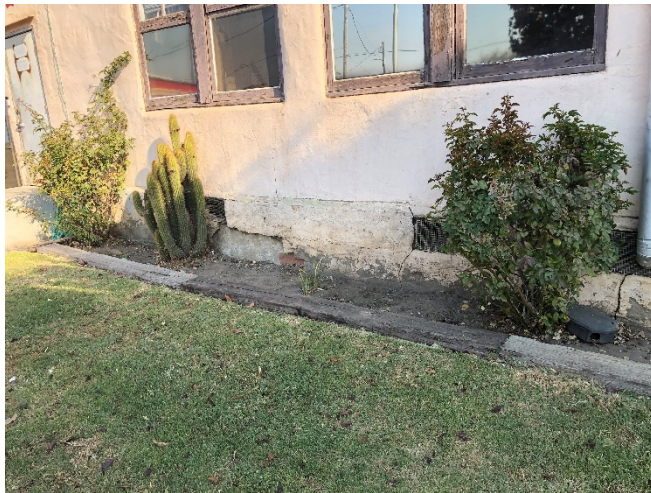
**Figure 6:** Exterior Wall of the Fire Department. Location of vents are consistent with the location of crushed of sill plates

Furthermore, it is speculated that ventilation hatches on the exterior walls allow water intrusion into the floor system. It was observed that the location of these exterior vents coincides with the location of where the sill plates start to completely crush.

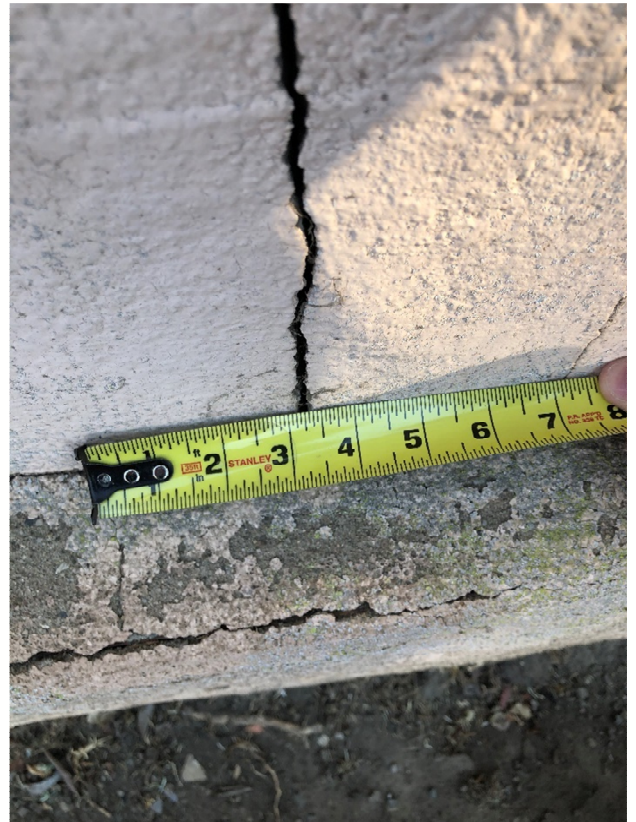
**Figure 7:** Cracks in exterior plaster likely leading to water intrusion into the wood floor framing system

In addition to the observed structural deficiencies, the exterior plaster appurtenances are separating away from the existing building finishes. The separation is likely allowing for water intrusion into the raised floor framing system which is likely the root cause to the sill plate and joist decay. Delayed maintenance to the exterior appurtenances will likely lead to further damage to the floor joists.

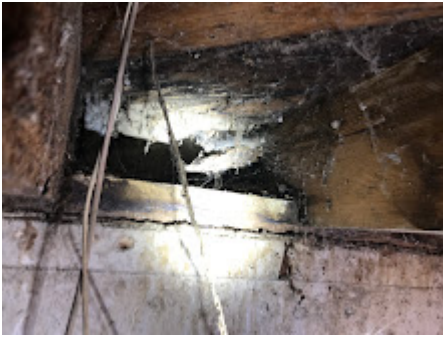
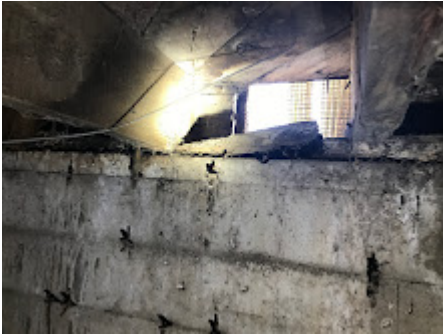
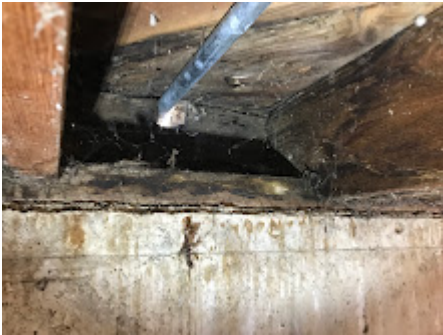
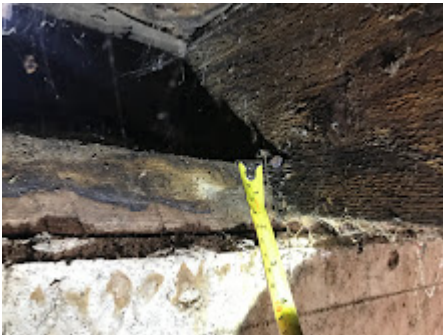
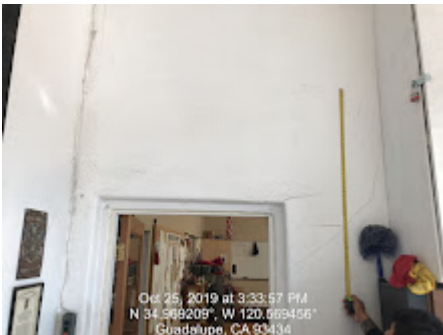
We have noticed multiple cracks developing in the wall between the fire station and the engine bay. I have marked the cracks so we can monitor the rate of spread. Per your request I took photos of that rotten/ water damaged floor joist and foundation bottom plate. The pictures have been placed in the F:drive in the Fire Department folder under Public Works Service Request Orders (F:/Firedepartment/PublicWorksServiceRequestOrders/FireDeptfoundation-floordamage10-25-19). Attached are just a few pictures for your reference. Also while we were under the floor we noticed that an existing water line is being put under strain as the building has settled it is now transferring the load on the pipe. And we also found a large section of a gas line approximately 100ft in length that is unsupported and sagging. The dip in the line between the 2 supporting points is about 24-30 inches.
